The cable design which has been associated with "rocket engine" defects, within the optical fiber, and later with low breaking strengths of the fiber, has been that defined by the ISS specification SSQ21654 (plus engineering modifications) and given the Boeing Company part number NFOC-2FFF-1GRP-1. Some small amounts of a similar part number, NFOC-2TFF-1GRP-1 was also used in ISS hardware; however, the problem investigation reported here does not concern this second part number. The production period of concern spans between June of 1996 to July of 1999. End users were Boeing-HB, ISS partners, and their subcontractors.

9.0 RECOMMENDATIONS

The initial goal of this investigation was to understand the cause of the "rocket engine" defects found in the fiber contained in the NFOC-2FFF-1GRP-1 optical cable being used by Boeing in International Space Station hardware. It was believed that if the root cause of the rocket engine defect could be found, the handling or the manufacturing processes (or both) could be engineered to eliminate the defect from future hardware. As the investigation progressed, these defects began to be understood as distinct and related to synergistic processes occ

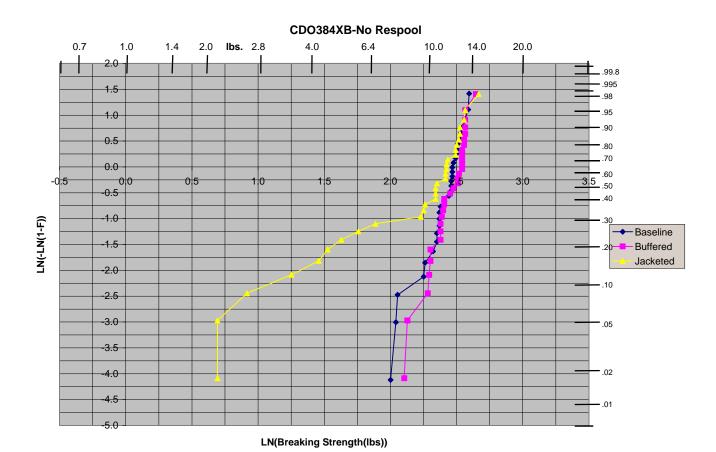
Figure 32 Strengths of DC0384 and DC0588 Fiber During Cabling

Figure 32a through 32d show that the fiber starts the process with high strength and every process step seems to weaken it, including the respooling process. They also show that the 588 fiber lot experienced greater weakening due to the cabling process that the 384 lot did, though they started with similar baseline strength. More bubbles were found in the polyimide coating during DPA on the 588 samples than on the 384 samples leading to continued interest in the correlation between the presence of the bubbles and latent defect sites.

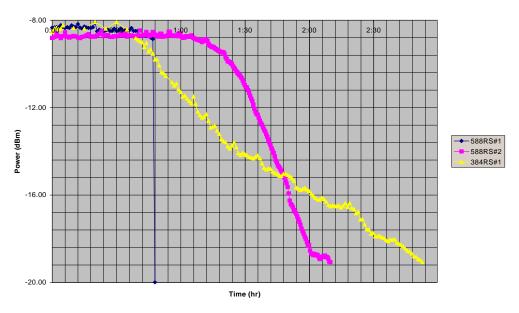
a. Run 1 through 3 with a HeNe source

Exposure to HF was used to try to measure the increase in etch related defects due to the respool and buffering cabling processes. Table 10 shows the results of this testing. The results point again to the propensity of the 588 lot to allow etch related defects versus the 384 lot. The 384 lot in this test, appears to be more robust with respect to defect creation or exacerbation associated with the respooling process. Figures 34a and 34b show the optical throughput during the etching period. [ref-25]

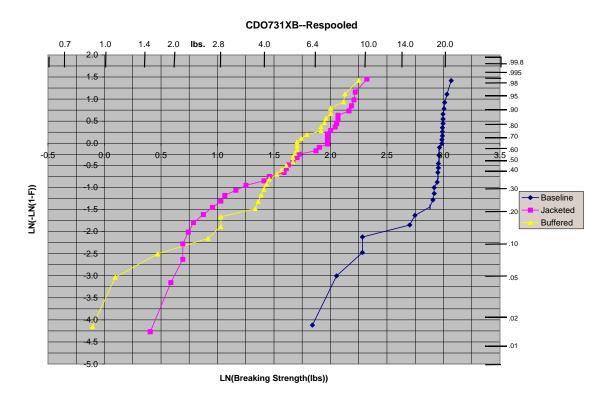
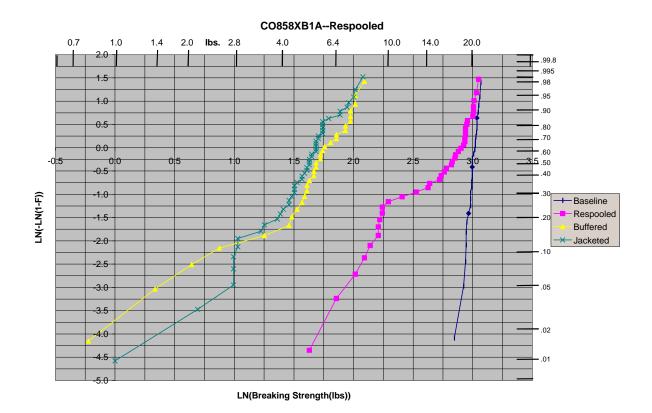
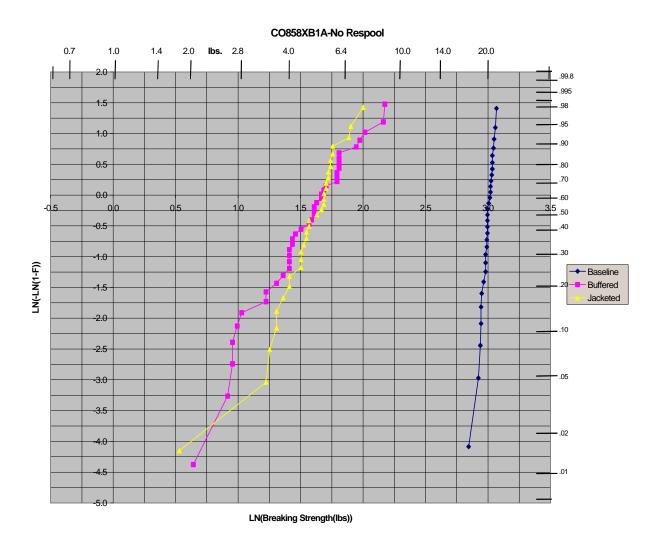
Figures 35 Strength for the Non-carbon Coated Fibers

Figure 35a through 35c show the affect of the various cabling processes on the fiber strength for the non-carbon-coated fibers. The unprocessed fiber has high strength, however as it goes through cabling, its strength is again increasingly reduced. The difference in the behavior between the two non-carbon coated fiber lots is still under study. [ref-26]

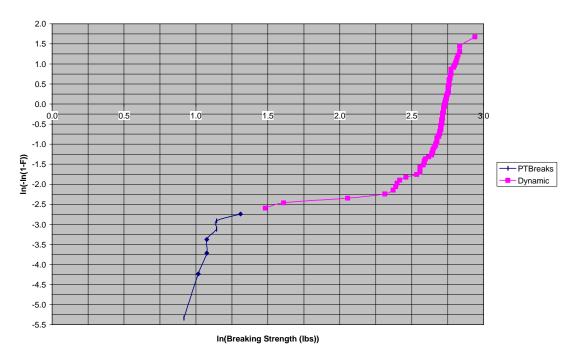
Figure 37 Hypothetical Break Strengths During Screen Compared to Actual Break Strengths on Proof Test Screened Sample

The fracture surfaces of the breaks found in the 04250 sample were analyzed and breaking strengths in lbs were calculated for them. These have been superimposed on the curve of breaking strengths found for the surviving sample, which was strength tested after the mandrel wrap screen. The lower (blue) section of Figure 37 represents the calculated values. The blue portion of the curve in Figure 38 are extrapolated values for the breaks, which occurred during the mandrel wrap screen in the 04245 sample. Figure 39 shows the dynamic strength data alone.
